Informational Bulletin

Close Call Incidents

Number: 24.008

Significant Incident After Action Review

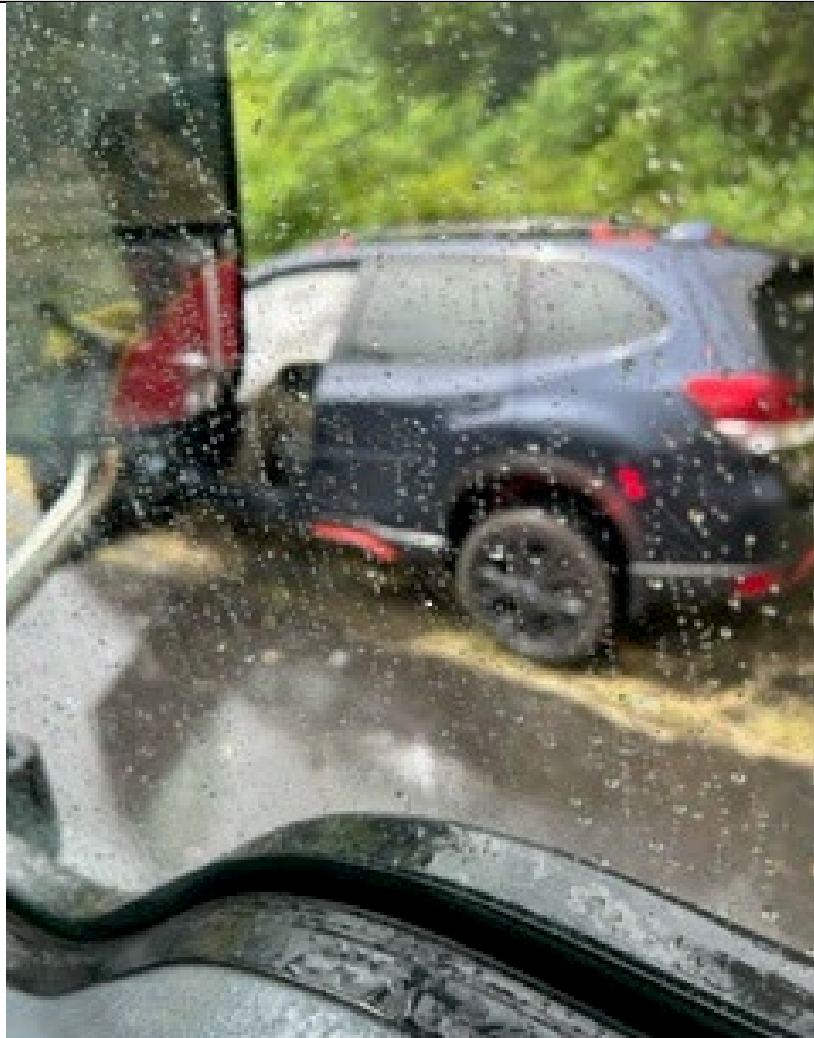
Advanced Ambulance 5 was first to arrive at 15:15 and reported a single vehicle off the roadway at the dispatched mile marker. Wagon 3 arrived 13 seconds after Advanced Ambulance 5 and took a blocking position in the number 2 lane to protect Advanced Ambulance 5. As the crew from Wagon 3 began to exit the apparatus to assess the incident, a vehicle approaching the incident lost control and slid into the incident scene narrowly missing Wagon 3 and the personnel that has already exited the vehicle. The vehicle came to a stop next to the officer side of Wagon 3. The vehicle left the roadway with enough force that all of the vehicle's airbags deployed.

This incident took place prior to personnel setting up traffic directing cones and prior to the arrival of the second engine company. Fortunately, our personnel operating on this incident were vigilant and exercising caution due to the weather conditions and incident location. There were no injuries to our personnel reported or damage to any county or volunteer apparatus.

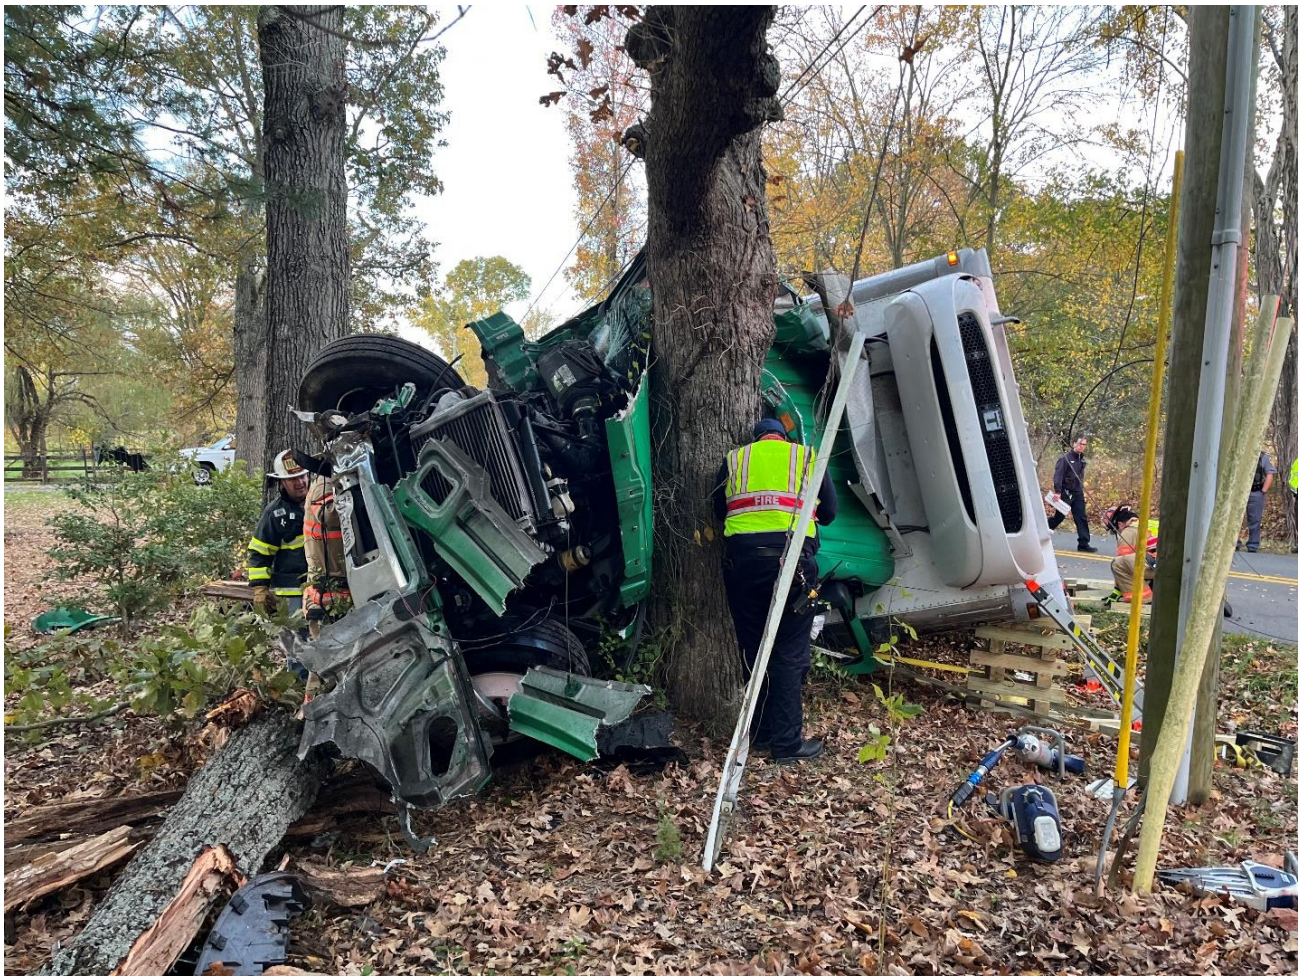
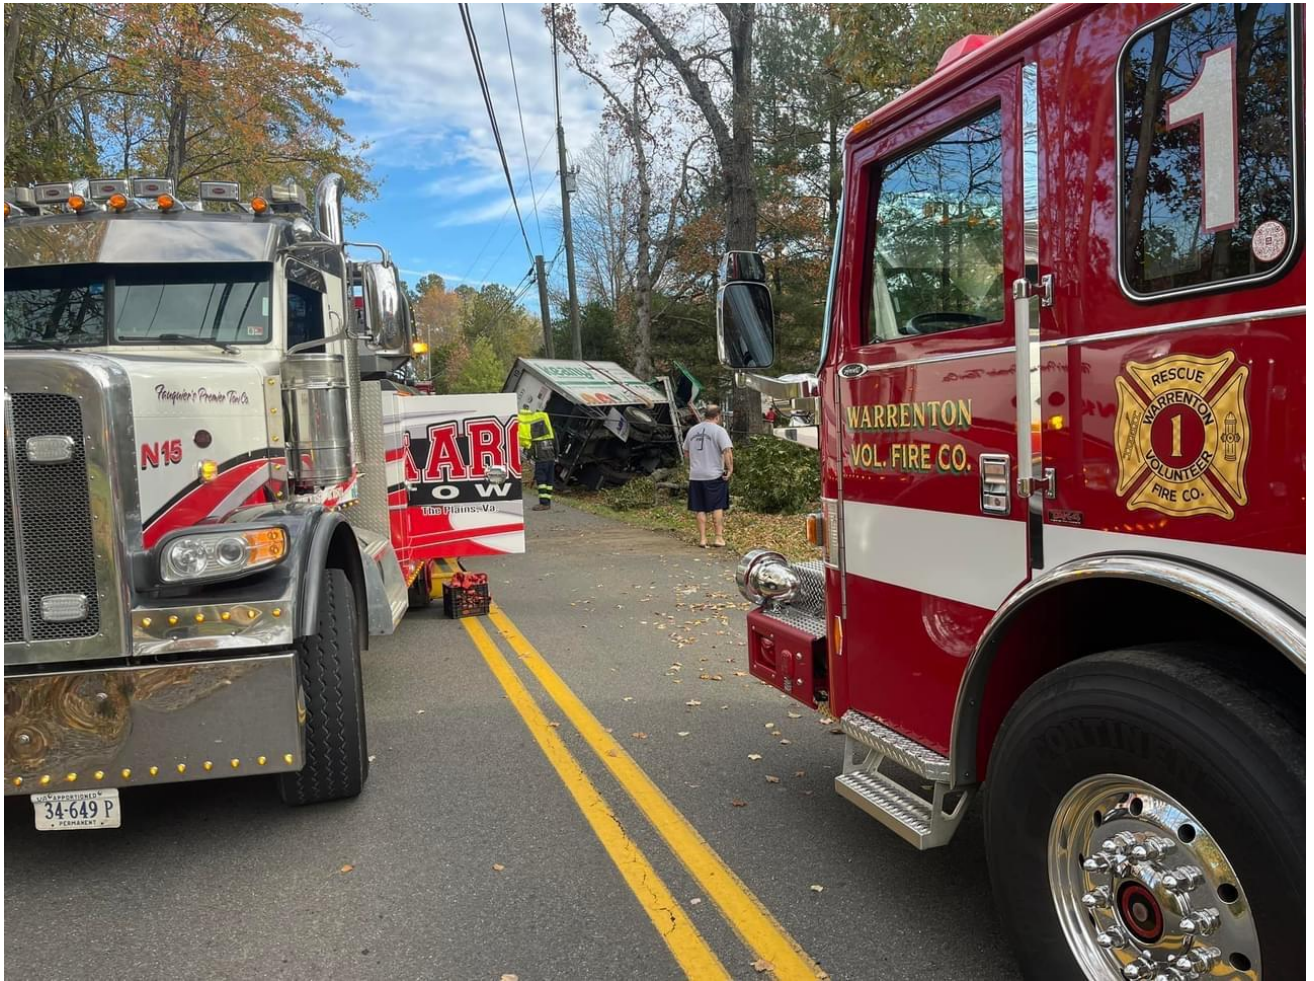
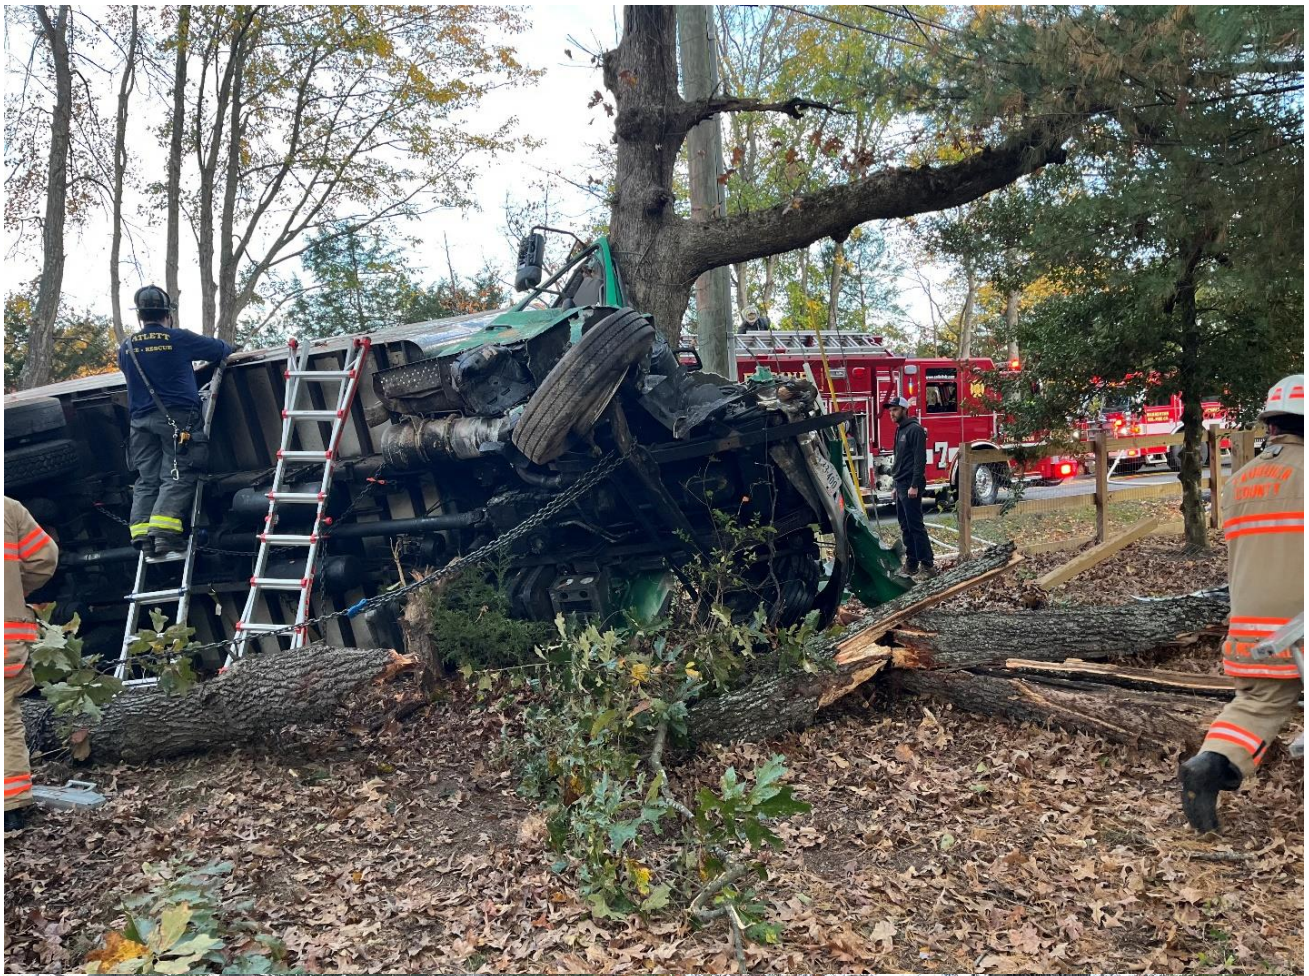
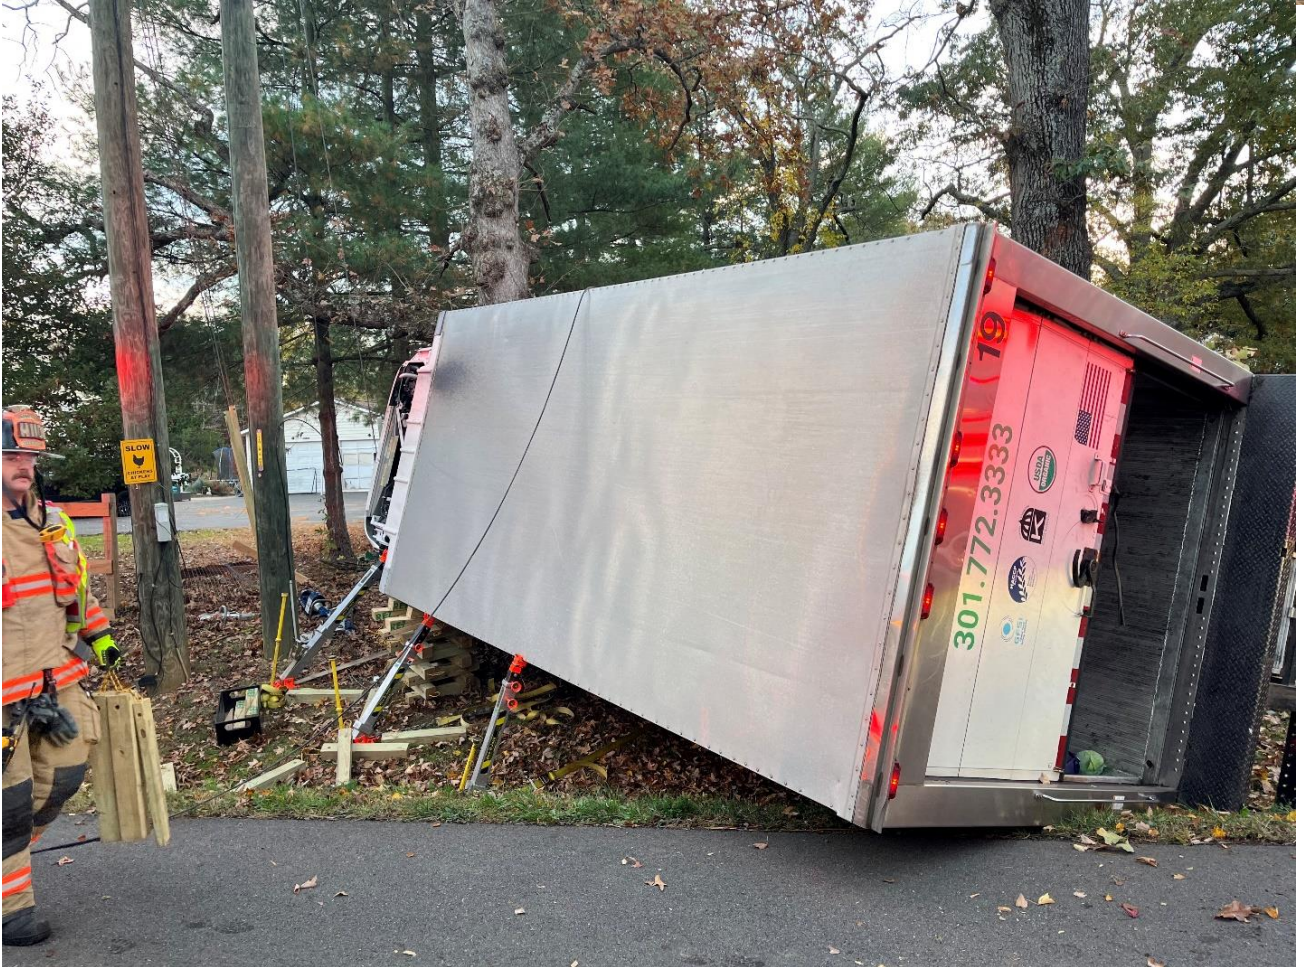
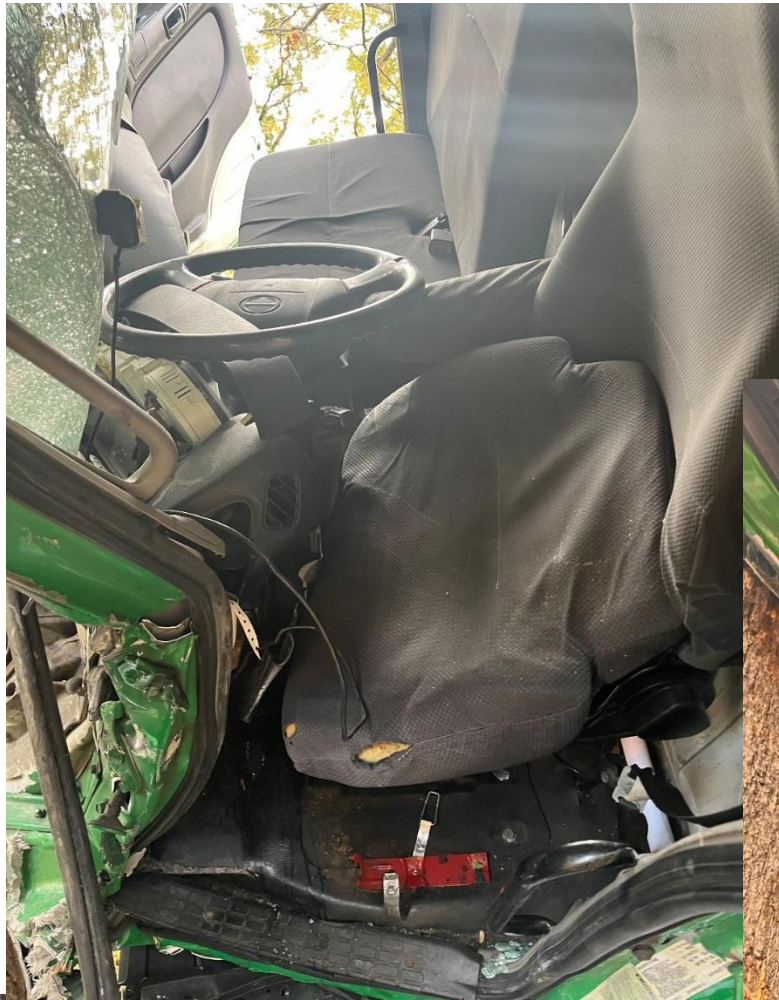
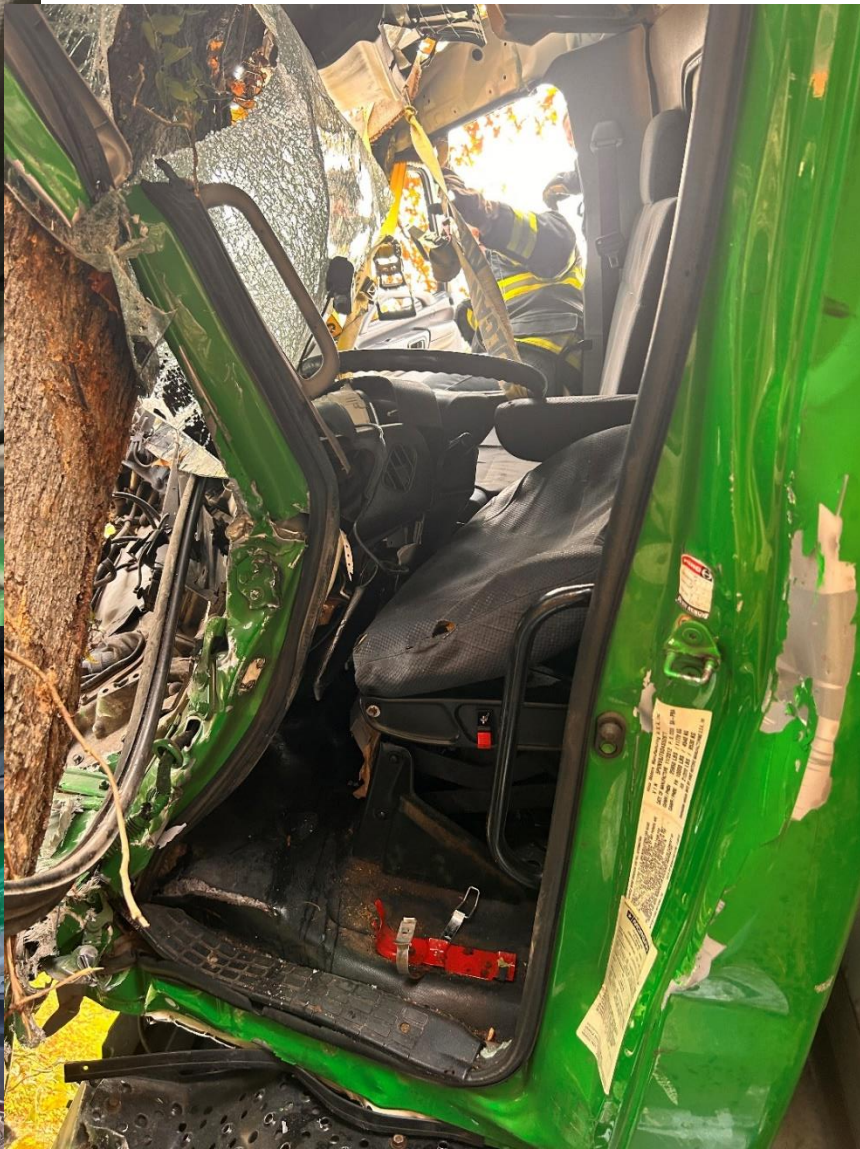
(Pictures Below)

Upon completion of size up, one occupant was noted to be trapped and pinned. Initial stabilization was completed with box cribbing and “Rescue Jack Struts”. Heavy Duty Rotator was requested.

AC Moore- Initially our plan was to lift (controlled roll) the truck off the tree via chain hoist, anchored to a nearby tree. As we began to lift, the truck showed signs of moving horizontally, so we stopped to readjust.

Lt Flinn- During the initial roll, it was noted that we were not getting enough vertical movement and strictly horizontal, due to the hinge point (vehicles tires) not biting into the soil. The decision was made to change the rigging points on the dirty side of the vehicle. Aaron’s towing had arrived on scene and their winch was utilized to complete the roll. This increased the speed at which we could roll the vehicle, and the distance we could allow it to travel without a reset. This changeover was done quickly due to Rescue Engine 7 and Rescue 1 carrying high quality chain that’s compatible with the towing industry.

Lt Flinn- The primary safety concern I noted was the use of “Rescue Jack Struts” to chase the controlled roll of the vehicle. Due to the design of the strut, personnel had to be placed close to the crush point of the vehicle and failure of the roll could have led to significant injuries. This is not really the intended use of these struts either, crews had difficulties keeping up with the roll of the vehicle. However, all equipment being utilized was well within weight limit capabilities and the required safety factors.

BFC Arft- Two Heavy Rescues should be added to all large vehicle with entrapment calls.

Paratech Struts utilizing air to chase the lift would have eliminated this concern.
